The Uniform Building Inspection Report™

Single Family Residence:
560 Wapello Cir, Sacramento, Ca

Inspection Date:
12/16/2011, 3:00:00 PM

Inspection Company:
Building P.I. Property Inspection Services
Steve Parrish
P.O. Box 478,
Elverta, CA 95626
916-930-0209

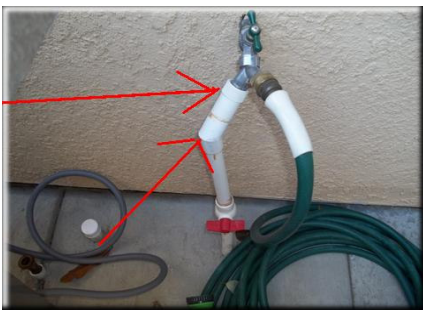
Photo: 0310.02 (1)

[N] 0310.02: Irrigation anti-siphon valve not located. In The Rear yard, Also Unprotected PVC Pipe Noted, Discretion advised. The significance of the finding is uncertain. Further study by a qualified licensed contractor is advised.
See series 0310.02 photo(s)

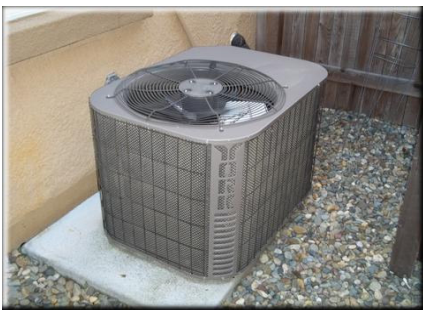
Photo: 2030 (1)

[M] 2030: Under 60 degrees F (cannot test air conditioner in cooling mode)
Monitor the situation on a regular basis. Corrections by a qualified licensed contractor, if and when necessary, are recommended.

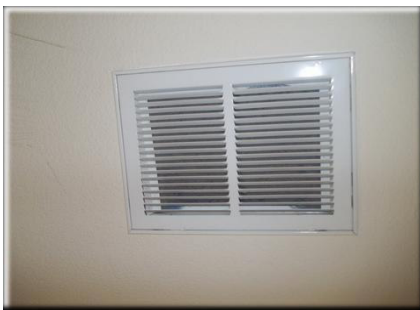
Photo: 2250.01 (1)

[E] 2250.01: Filter dirty.
Repair, alteration or replacement usually improves the efficiency of the component or system.
See series 2250.01 photo(s)

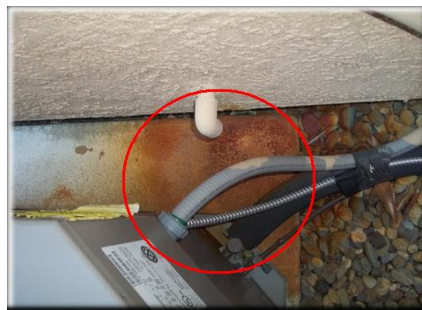
Photo: 2310.04 (1)

[N] 2310.04: Condensate drain improper.
Possible That The Secondary Drip And The Primary Drip Pipes Are Crossed (Rust Noted) Discretion advised. The significance of the finding is uncertain. Further study by a qualified licensed contractor is advised.
See series 2310.04 photo(s)

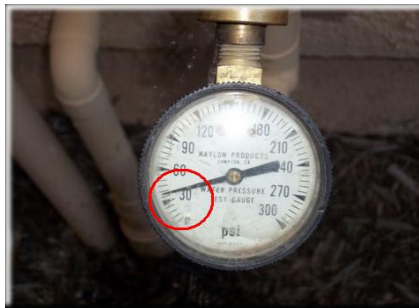
Photo: 4400 (1)

[M] 4400: Water pressure high or low.
Recommend 60 to 70 PSI.

Preassure Low (System Preassure Pump Added)
Monitor the situation on a regular basis. Corrections by a qualified licensed contractor, if and when necessary, are recommended.

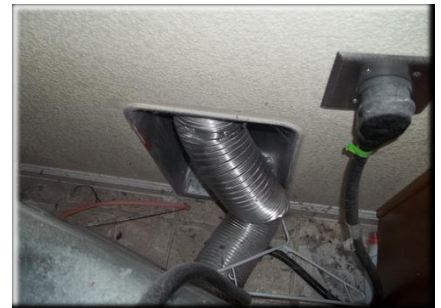
Photo: 4820.13 (1)

[A] 4820.13: Dryer faulty or otherwise amiss.
Suggest Cleaning Dryer Vent Before Use!
Maintenance, alteration or repair could be expected to improve component appearance and may decrease deterioration.

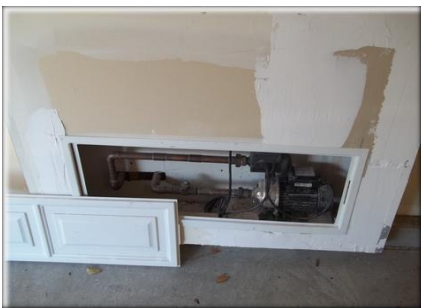
Photo: 4905 (1)

[M] 4905: Plumbing modifications noted.
Monitor the situation on a regular basis. Corrections by a qualified licensed contractor, if and when necessary, are recommended.

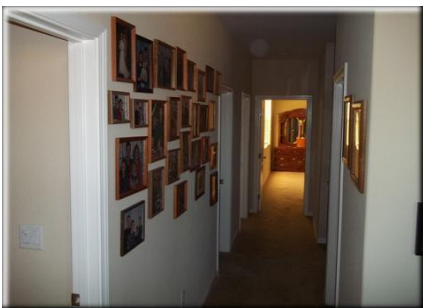
Photo: 7040.03 (1)

[E] 7040.03: Wall holed.
Minor Holes From Wall Pictures Noted (Minor Repairs) (Suggest Painting With A Heavy paint Roller) Repair, alteration or replacement usually improves the efficiency of the component or system.
See series 7040.03 photo(s)

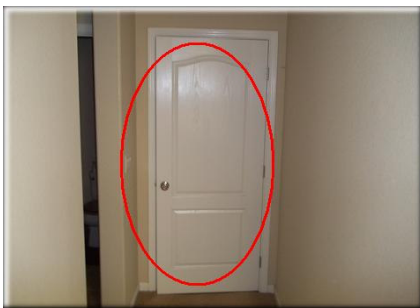
Photo: 7330.05 (1)

[E] 7330.05: Door faulty or otherwise amiss.
Various Upstairs Doors Need Adjustment, (not latching Closed) Repair, alteration or replacement usually improves the efficiency of the component or system.
See series 7330.05 photo(s)

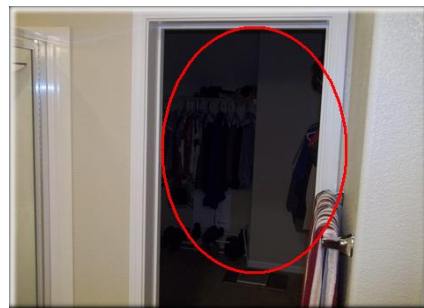
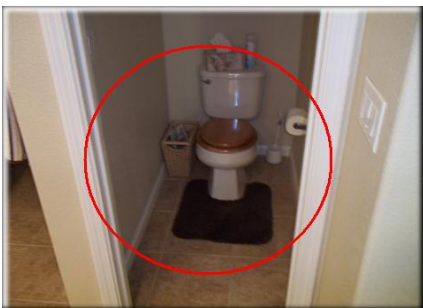
[E] 7340.01: Door removed.
At The Master Bathroom, Repair, alteration or replacement usually improves the efficiency of the component or system.
See series 7340.01 photo(s)

[E] 7340.01: Door removed.
At The Master Closet, Repair, alteration or replacement usually improves the efficiency of the component or system.
See series 7340.01 photo(s)

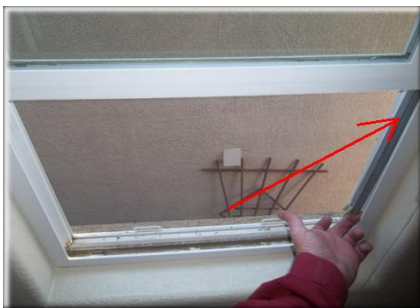
Photo: 7500.11 (1)

[N] 7500.11: Window opening mechanism damaged.
At Various Windows Upstairs And Down Stairs Window Springs loose Or Not attached, Suggest A Complete Evaluation Of All Windows, Discretion advised. The significance of the finding is uncertain. Further study by a qualified licensed contractor is advised.
See series 7500.11 photo(s)

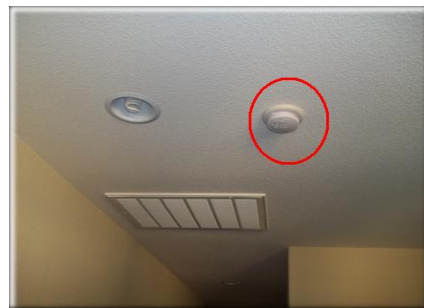
Photo: 7820.01 (1)

[C] 7820.01: Carbon monoxide alarm not installed.
Suggest Adding To Lower And Upper Levels! HEALTH/SAFETY CONCERN, Caution is advised. The finding could be, or could become, hazardous under certain circumstances. The opinion of a qualified licensed contractor is recommended.
See series 7820.01 photo(s)

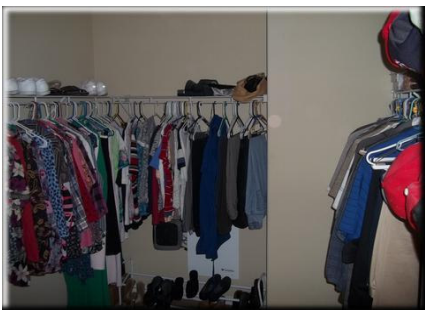
Photo: 7920 (1)

[M] 7920: Access impaired.
HOUSE FURNISHED UNABLE TO INSPECT VARIOUS LOCATIONS, When House Is Empty, Monitor the situation on a regular basis. Corrections by a qualified licensed contractor, if and when necessary, are recommended.
See series 7920 photo(s)

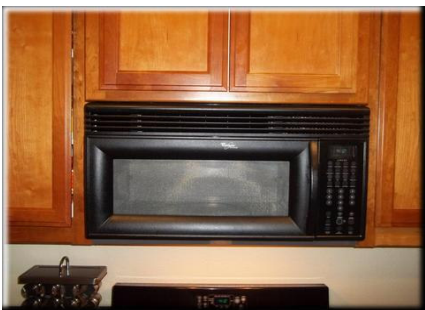
Photo: 8090.03 (1)

[N] 8090.03: Microwave faulty or otherwise amiss. Unit Does Not Perform Correctly, Discretion advised. The significance of the finding is uncertain. Further study by a qualified licensed contractor is advised.
